REFERENCE	BT_2013_FR1.6_1_UK
DATE	May 1st, 2013
SUBJECT	Brake reservoir mounting, New exhaust, Wheel stud replacement
PART	Brake reservoirs, Exhaust, Wheel stud

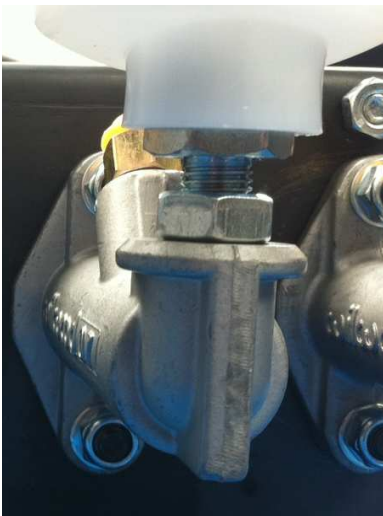
Wrong old brake reservoir mountings have been pointed on some FR1.6 leading to potential brake liquid leaking. An evolution of the old brake reservoir assembly has been done as shown below:

Old mounting

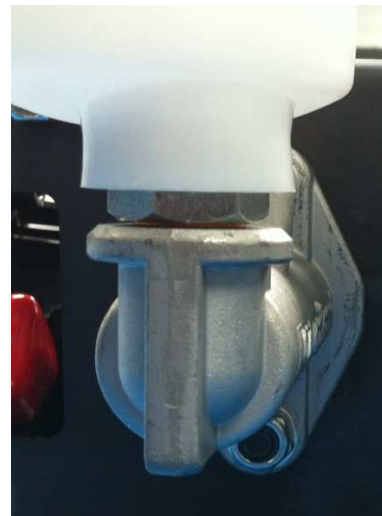
New mounting

To achieve the new mounting, you must respect the following instructions:

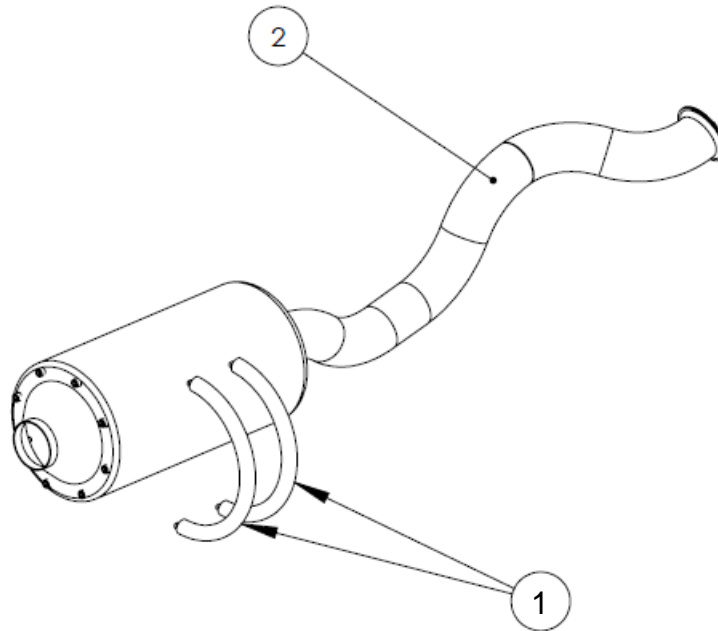
Due to lots of 90db exhaust failures, a new exhaust has been designed respecting the 95db noise level.

This exhaust (2) includes under the same reference a muffler, a catalyser and the intermediate exhaust line. The genuine exhaust supports remain the same to fit this exhaust, except the muffler support springs (1) which are longer than the genuine one.

This new exhaust must now be used in FR1.6 NEC & SWE championships.

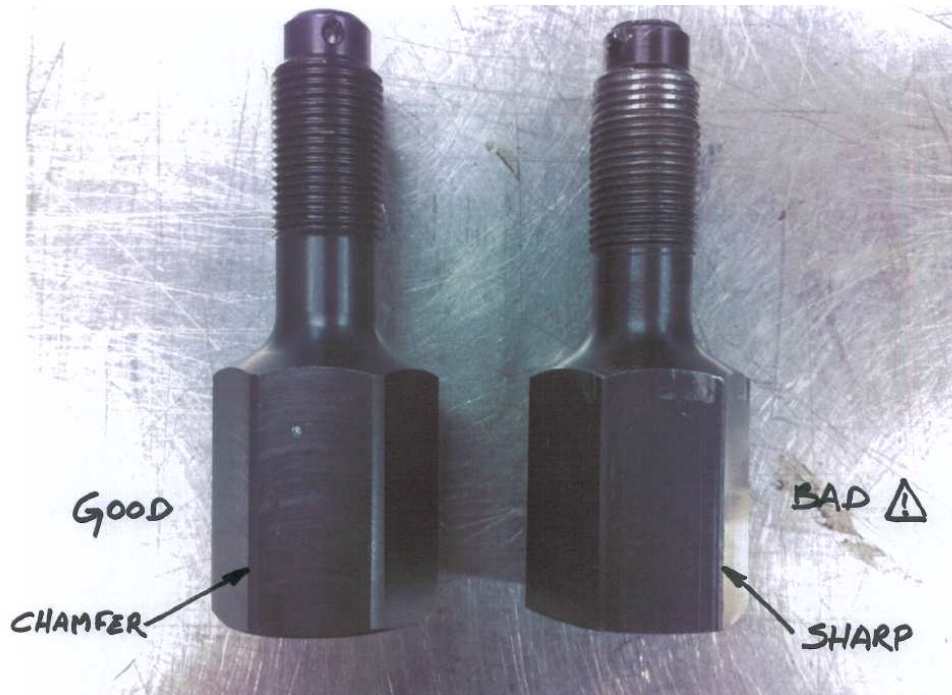
A batch of wrong wheel studs has been pointed with a too short inner threaded section. Some of them have been fitted on some cars.

The wrong wheel studs can be recognized as follows

Due to a potential risk of wheel coming loose, these wrong wheel studs must be replaced immediately following the procedure below:

- Check all your wheel studs fitted on your car and available in your spare parts
- In case of wrong wheel stud, lock the wheel hub with a roll pin set or a screwdriver between brake disc and calliper for the rear, or using the specific tool G04-20A001V1 for the front.
- Heat the wheel stud around 200°C with a heat gun in order to overheating and ruining the threadlocker (Loctite).
- Loose the wheel stud. The loosening torque must not exceed 180Nm. If the loosening torque is higher, the threadlocker is not enough ruined. Heat again the wheel stud.
- Clean the new wheel stud from the remaining Loctite either the homocinetic joint for the rear or the front bearing stud for the front.
- Degrease the new wheel stud thread and put Loctite 270 on the homocinetic joint for the rear or the front bearing stud for the front. Put a sufficient amount of Loctite.
- Tight the new wheel stud to 180Nm.
